An Arboricultural Assessment on Lands at 'Boherboy', Saggart, Co. Dublin (Phase 3 of the LRD Application)

Prepared for: Kelland Homes Ltd & Aderrig 4 Residential Ltd (Planning
Applicants)

Date: 13th November 2025

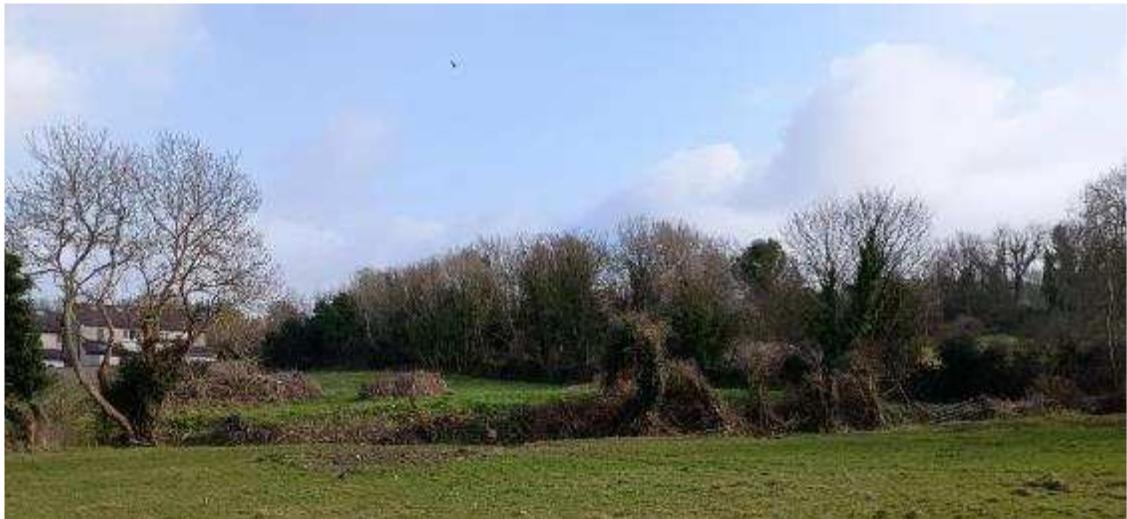
West side of Hedge No. 2A

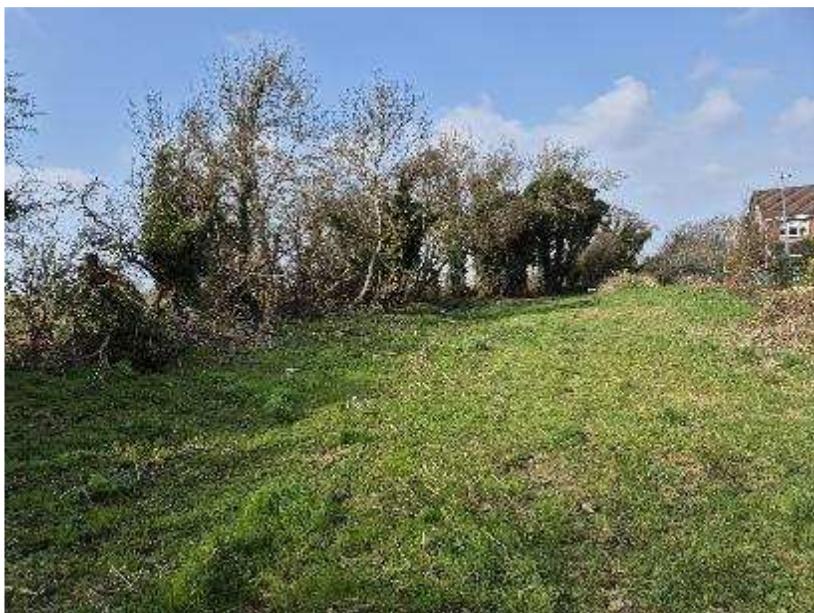
East side of Hedge No.2A

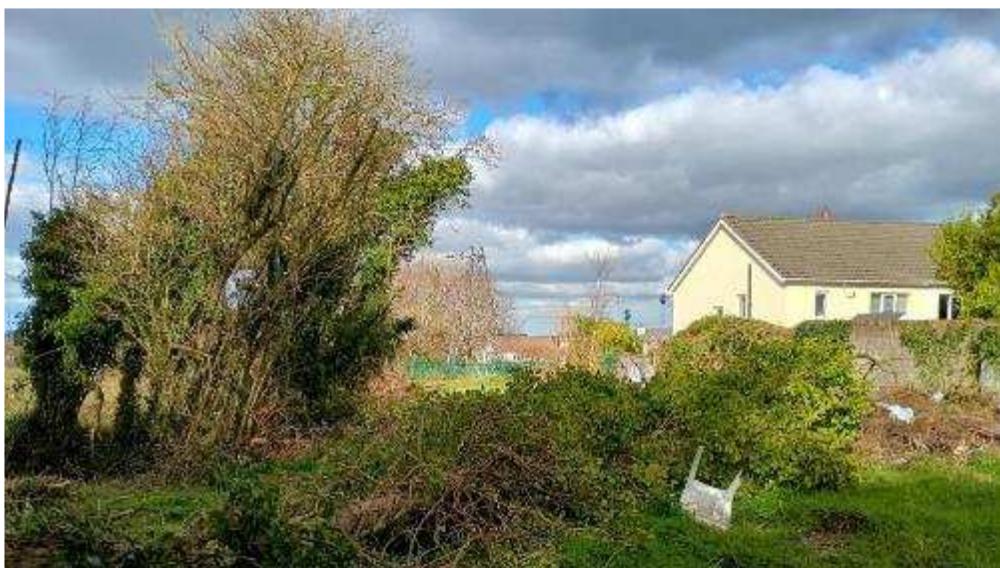
East side of hedge No.2A

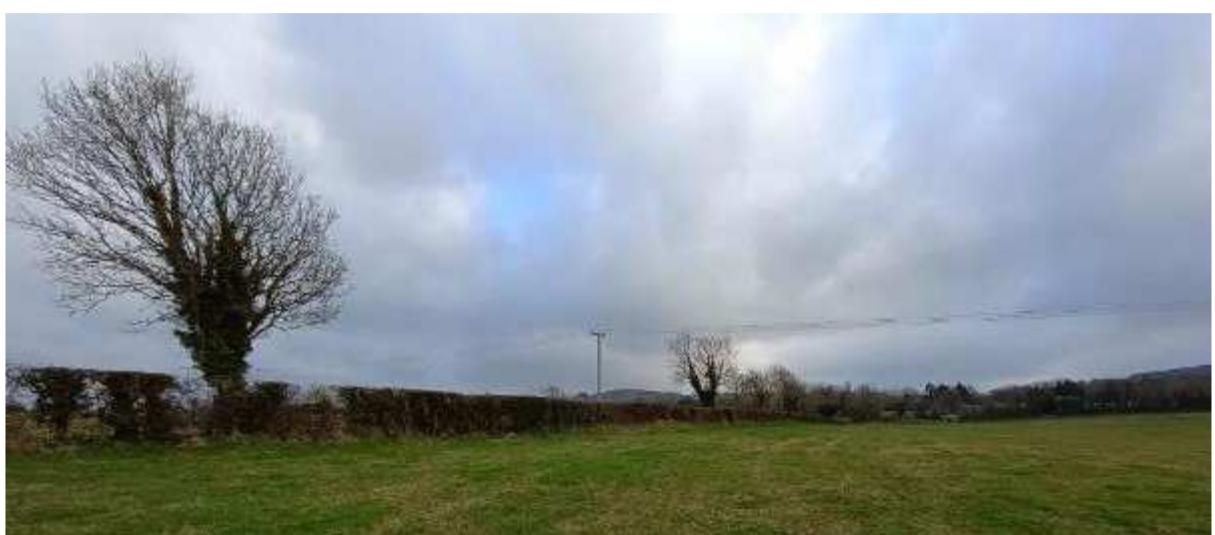
Hedge No. 4

Along the central Hedge (No.4) and the western Hedge (No.6) the existing drainage ditches will be developed as swales to form part of the drainage network within this development and any widening of these will need to work out away from the hedgerow banks to ensure no damage is caused that could result in root damage to the hedge and tree vegetation.

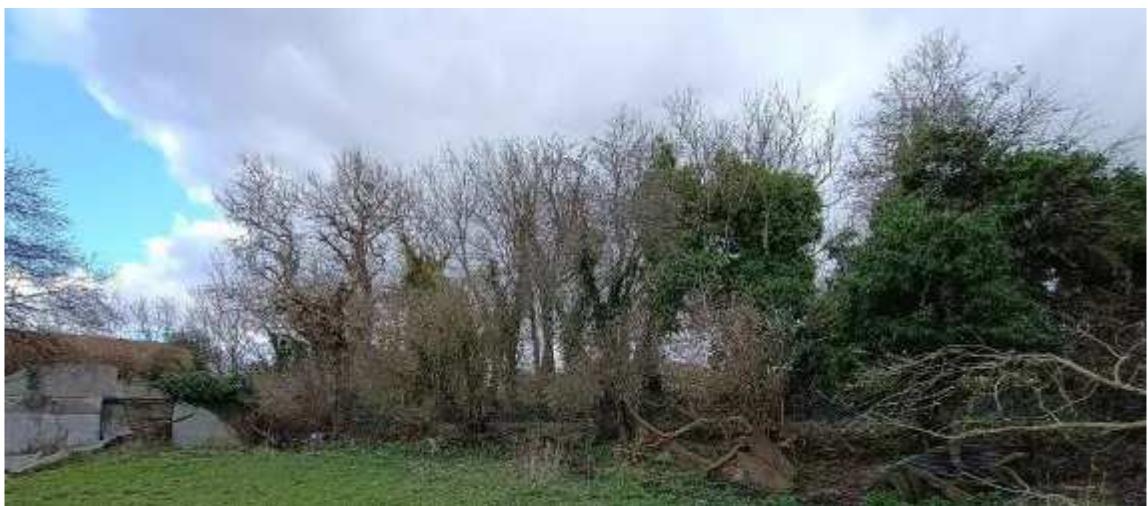
Eastern end of Hedge No.5.

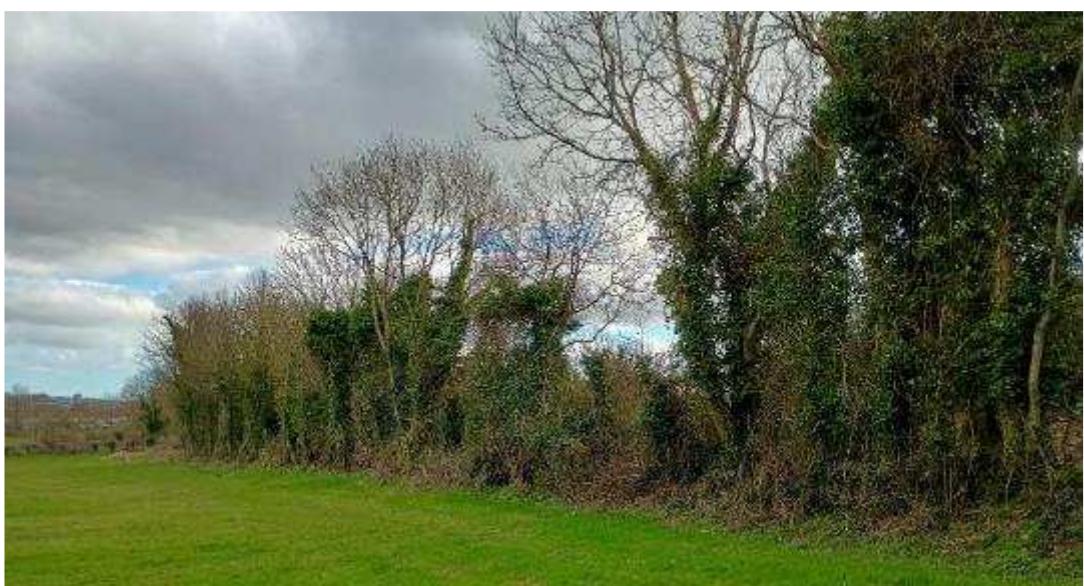
Western end of Hedge No.5.

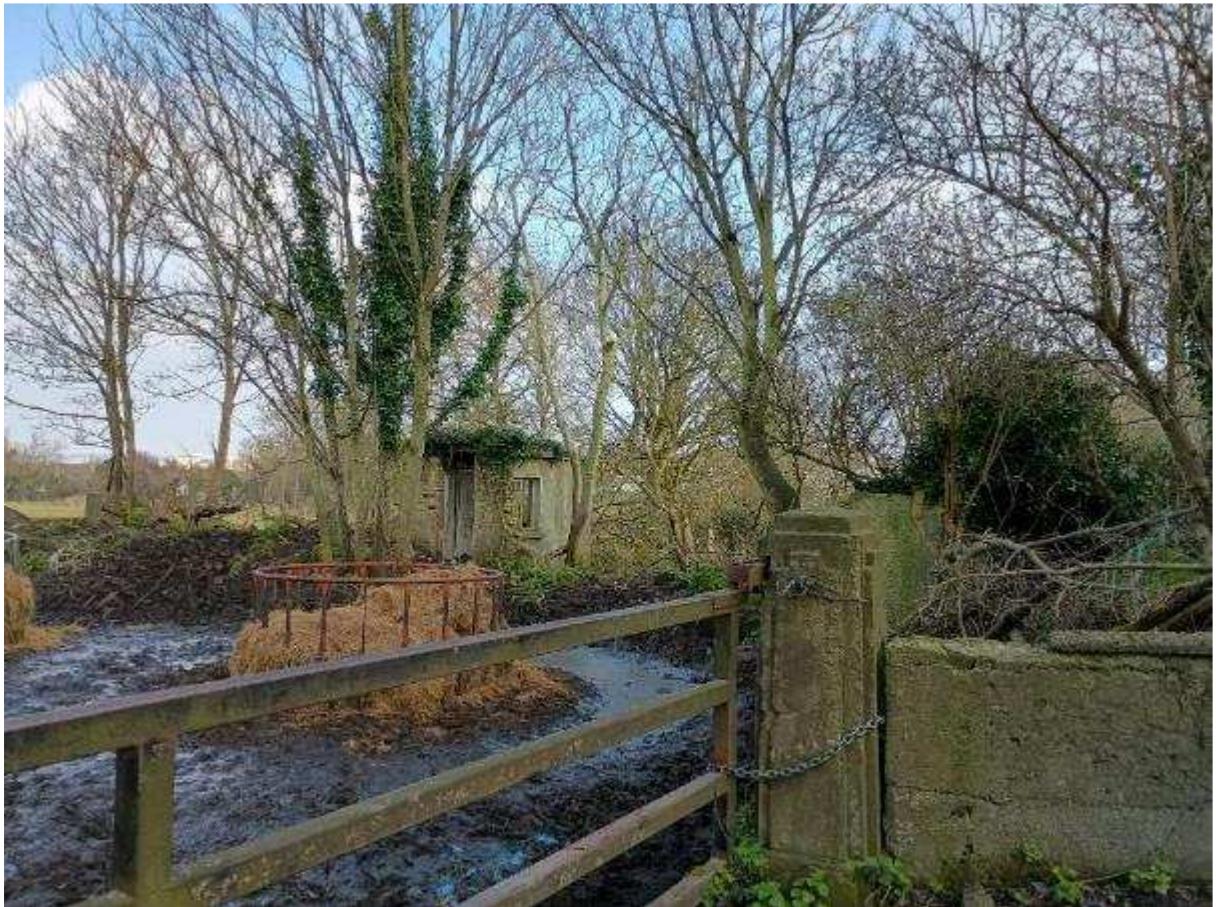
Trees that self-seeded around old farmyard.
